Close Out Documents

AP-78 – 4625 Fillmore St.

Asbestos Abatement and Structural Demolition

Re: SSCR AP-78 4625 Fillmore St.

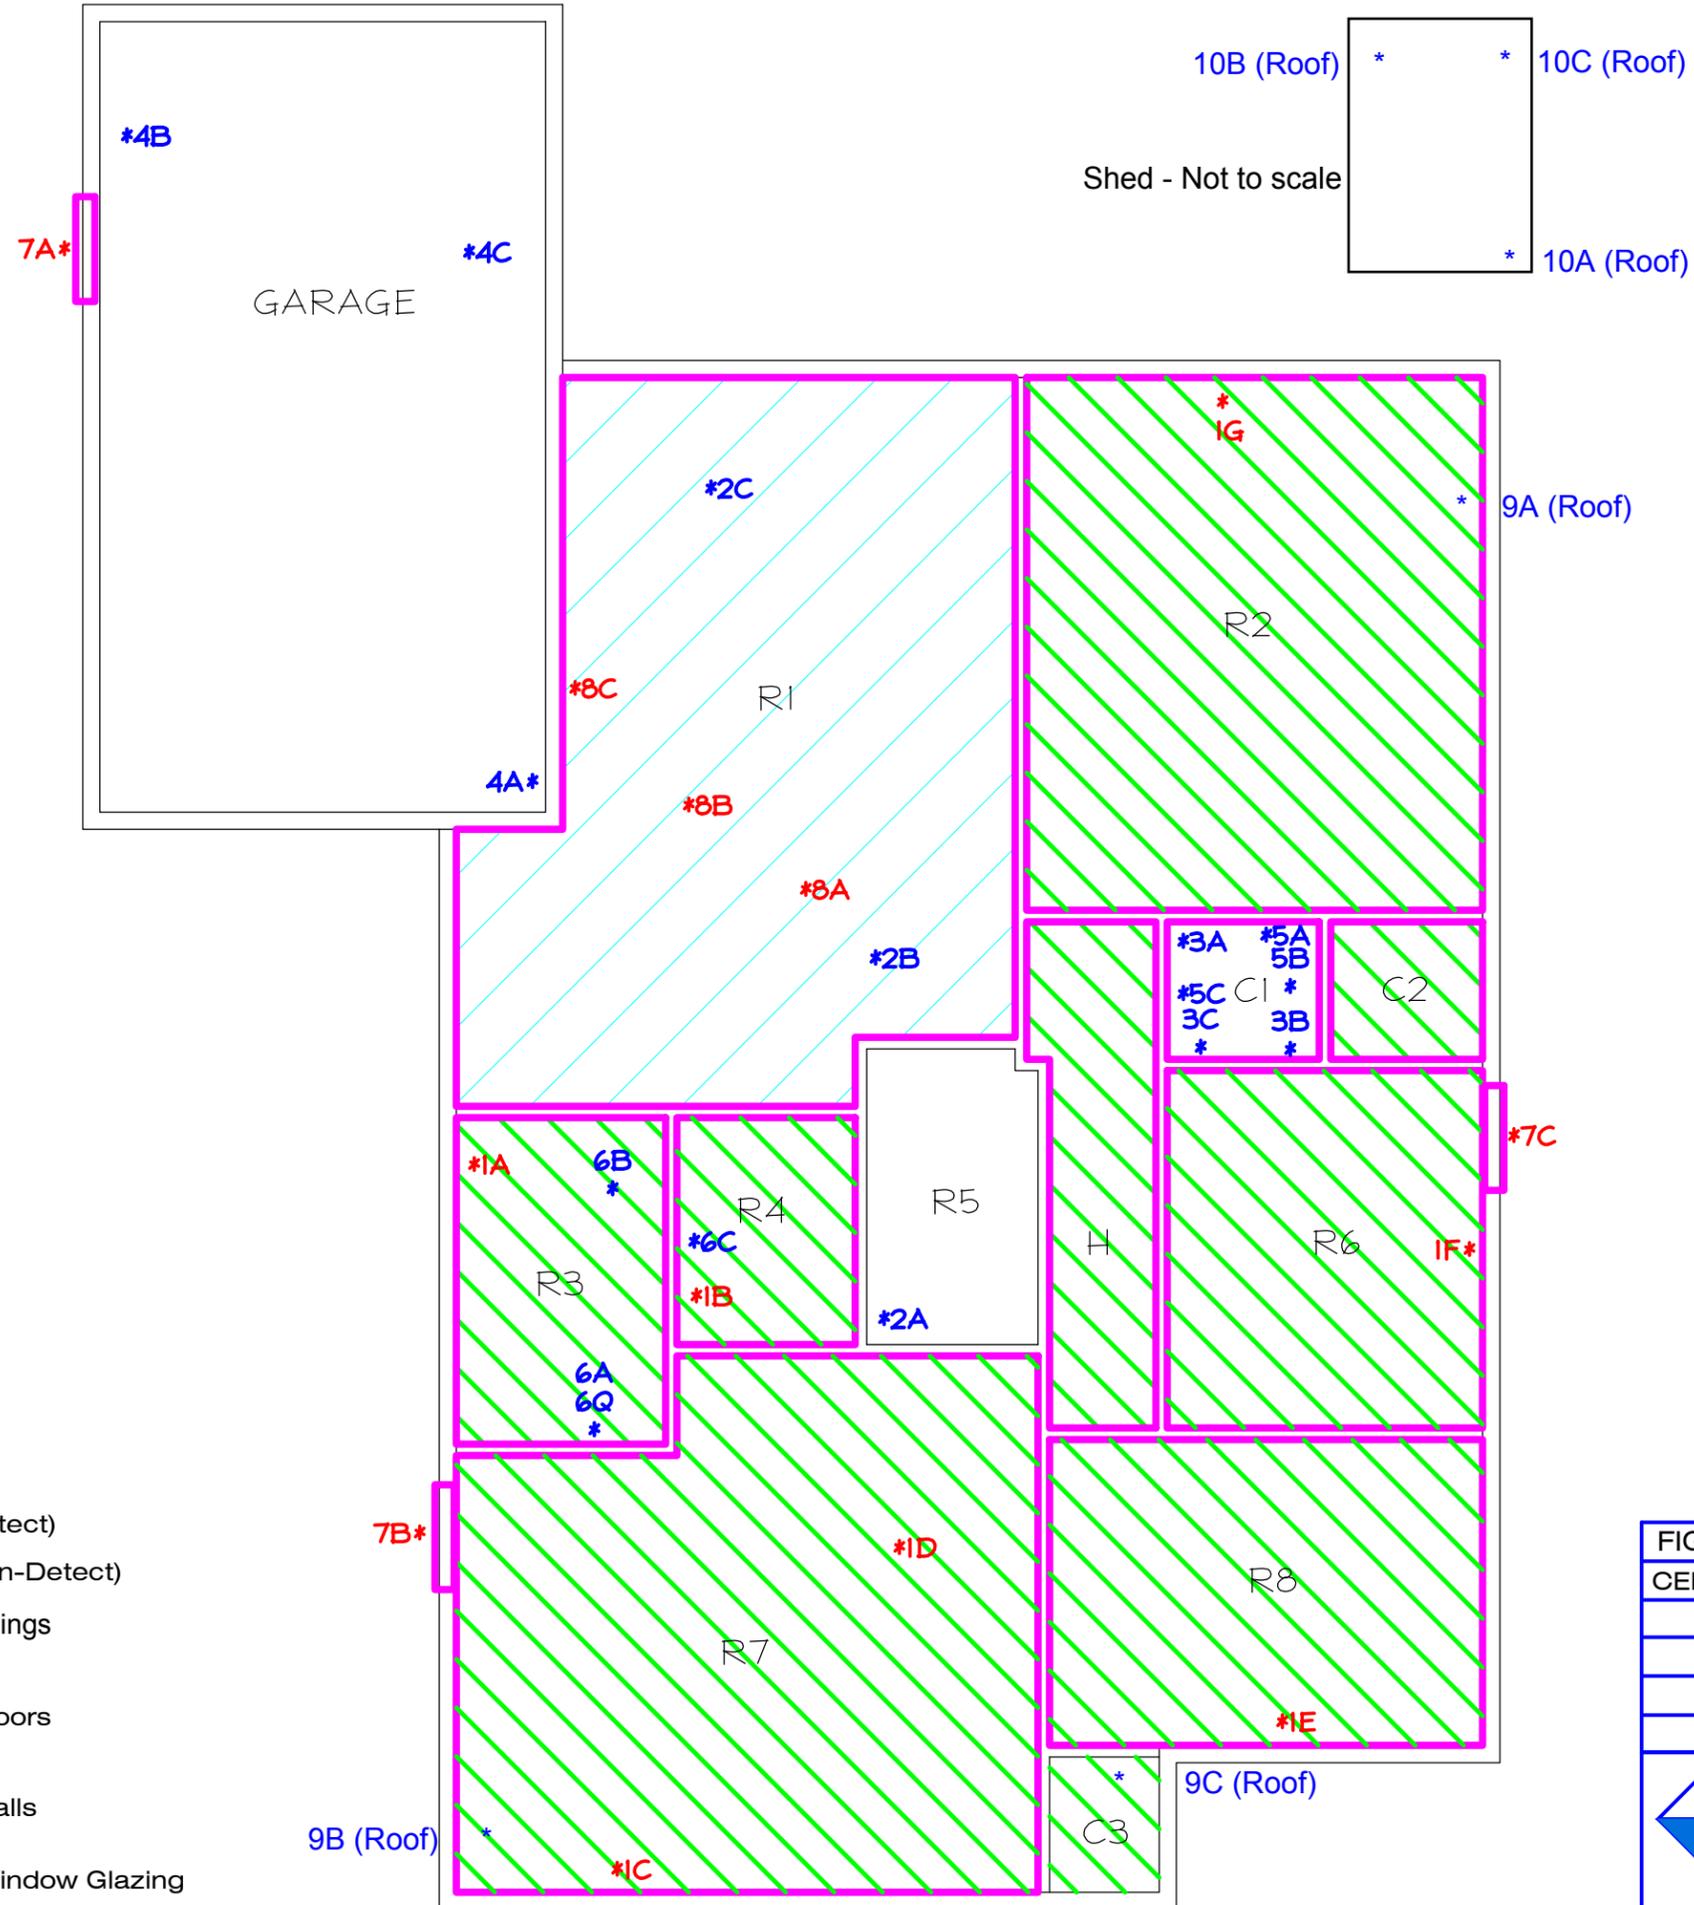
- R1 = Room Numbers
- #1A = Asbestos Samples (Detect)
- #4B = Asbestos Samples (Non-Detect)
-

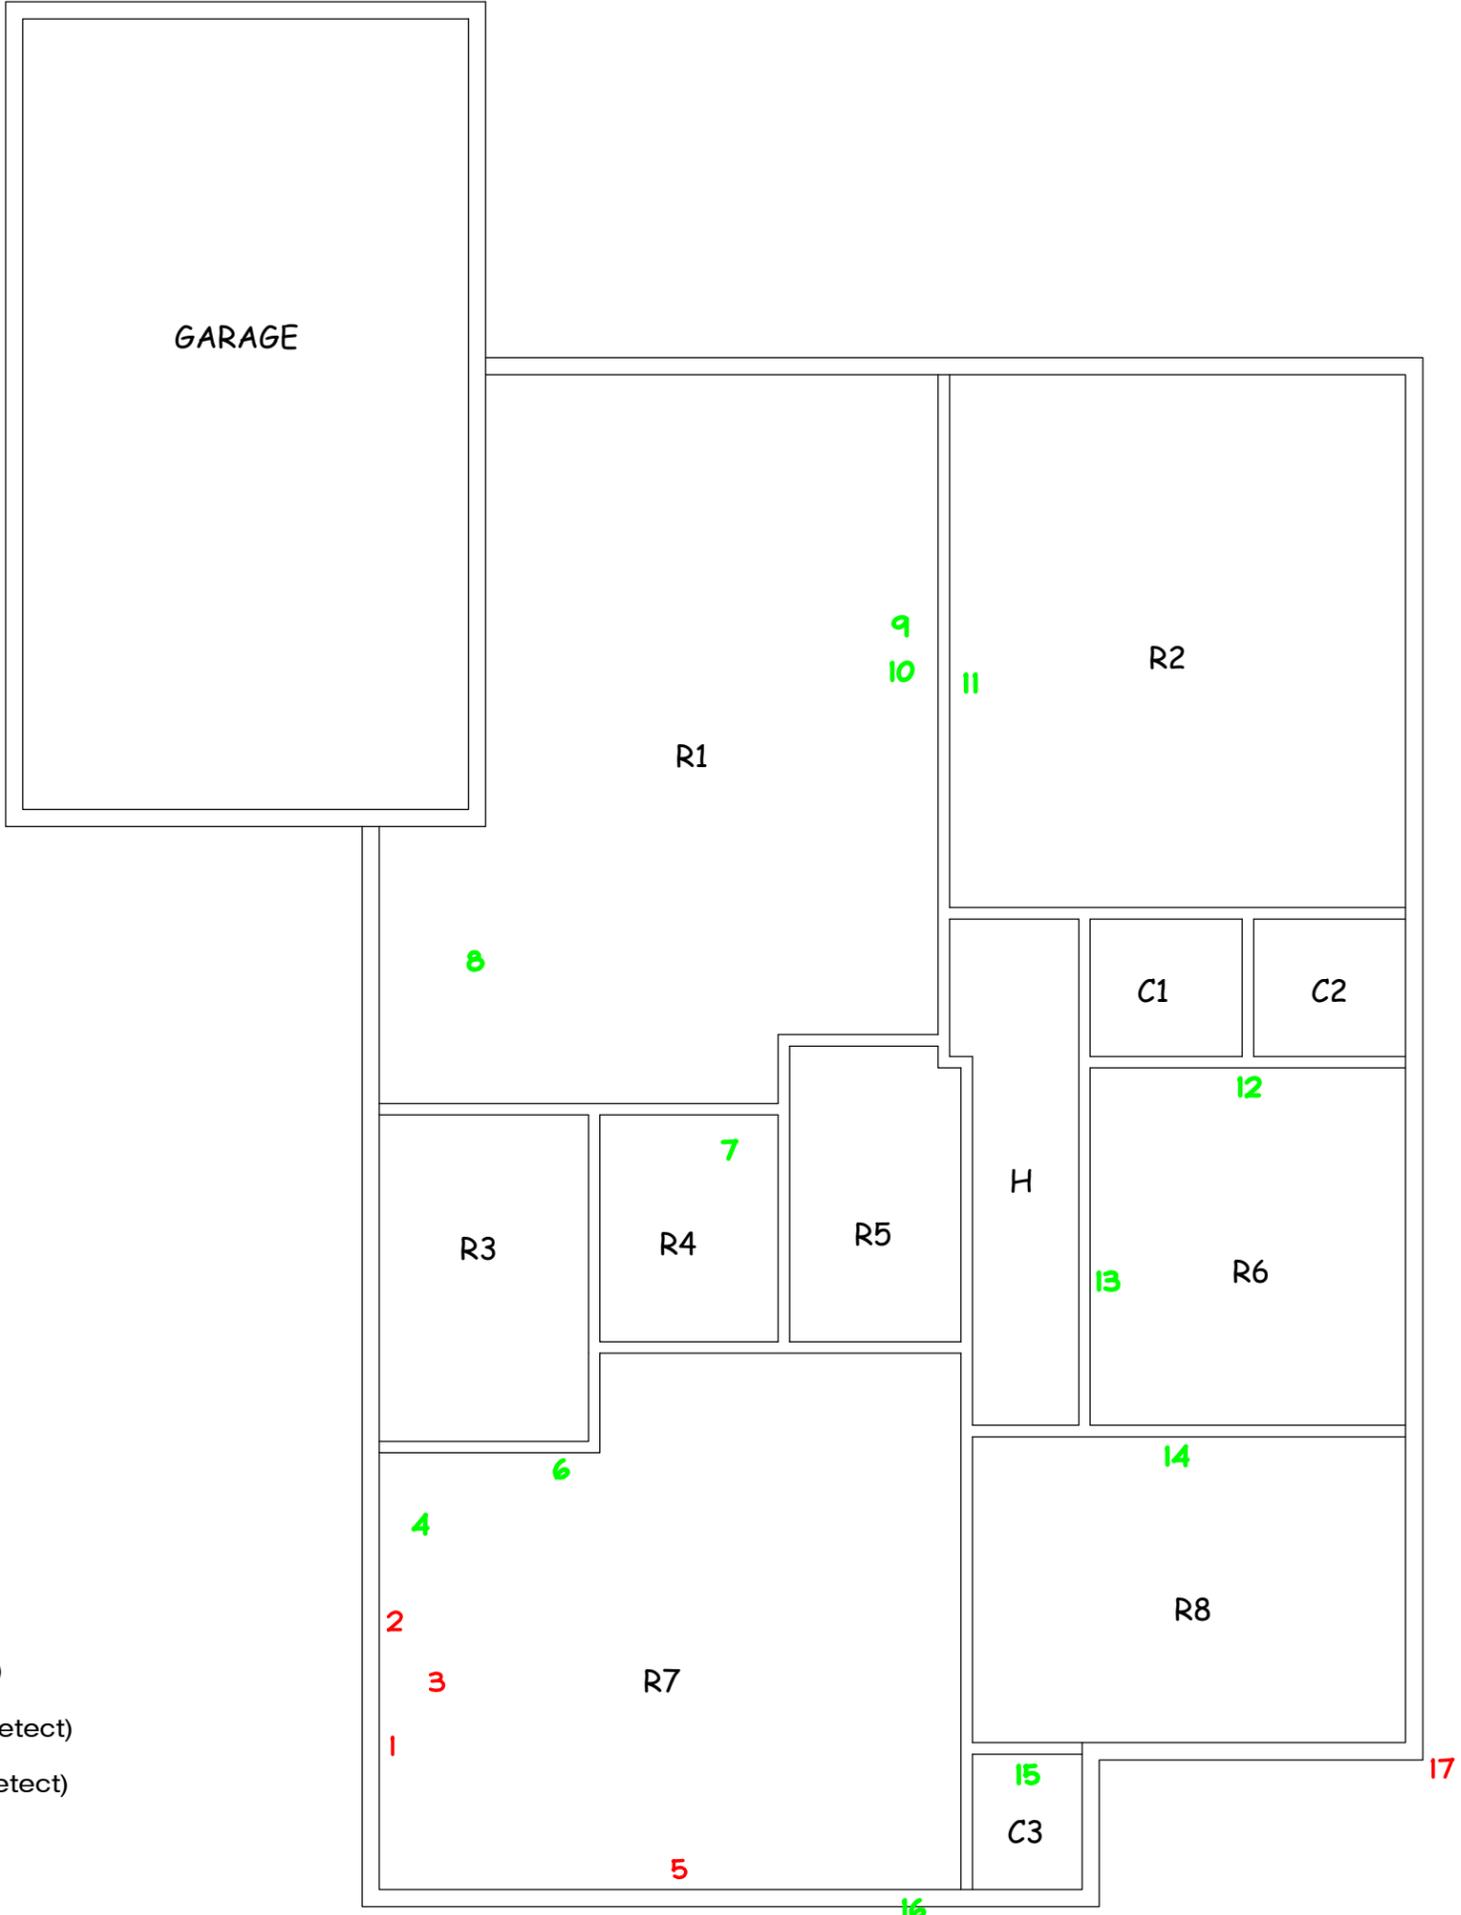
- R1 = Room Numbers
- 4 = Lead Base Paint (Detect)
- 4 = Lead Containing Paint (Detect)
- 4 = Lead Base Paint (Non-Detect)

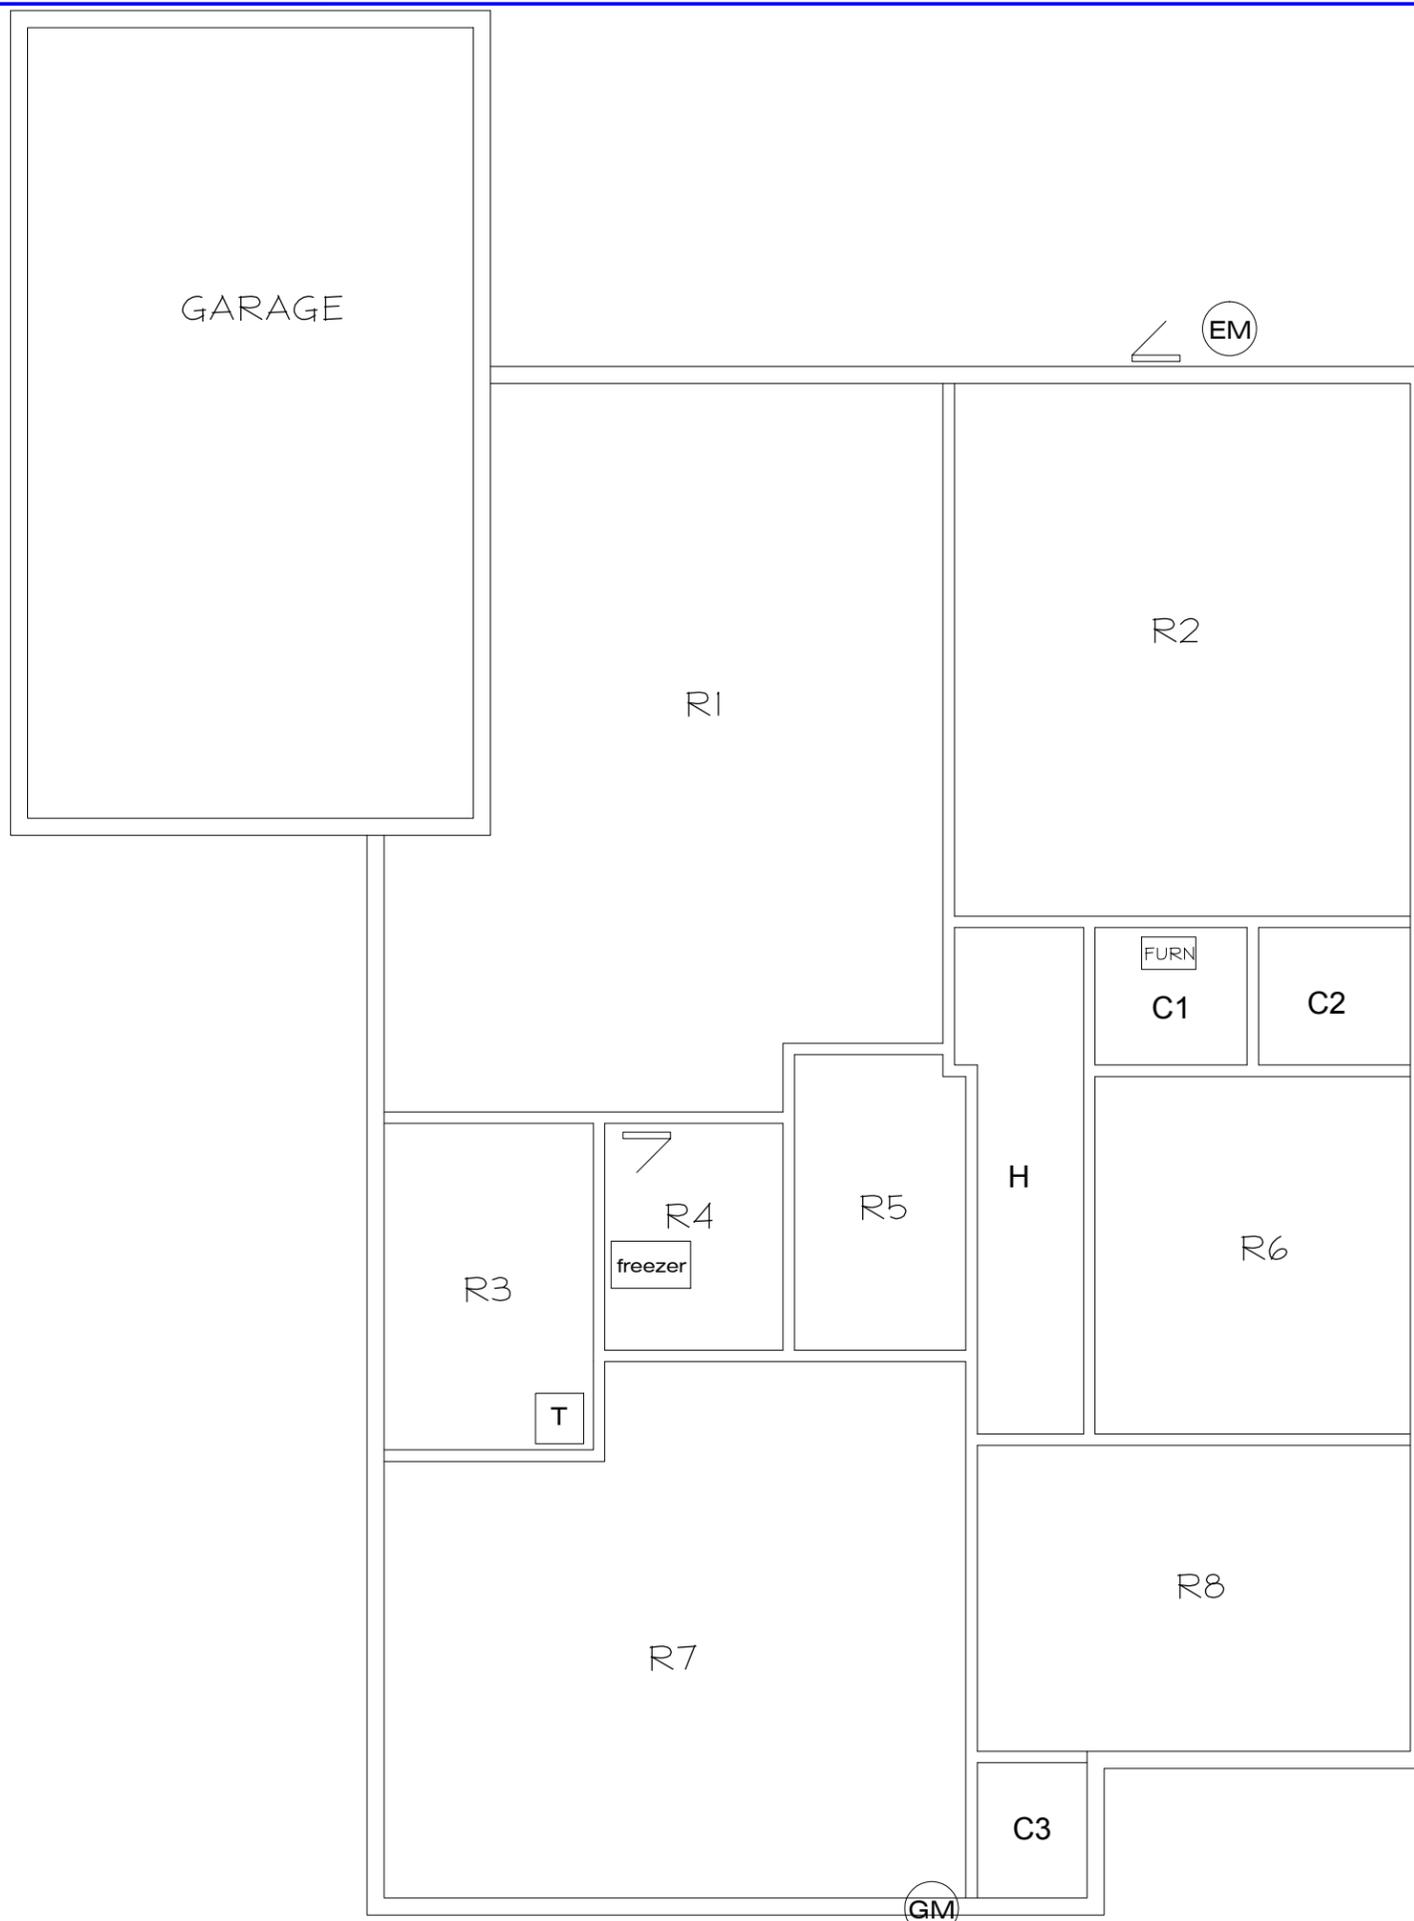
- R1 = Room Numbers
- FURN = Furnace
- T = Thermostat
- EM = Electrical Meter
- freezer = Freezer
- = Breaker Panel
- GM = Gas Meter

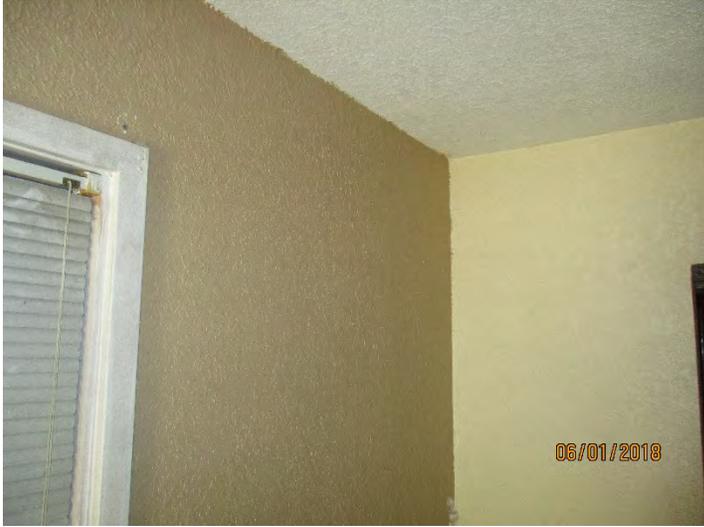
Knockdown Textured Drywall

Samples Represented –
4625F-R3-TD1A
4625F-R4-TD1B
4625F-R7-TD1C
4625F-R7-TD1D
4625F-R8-TD1E
4625F-R6-TD1F
4625F-R2-TD1G

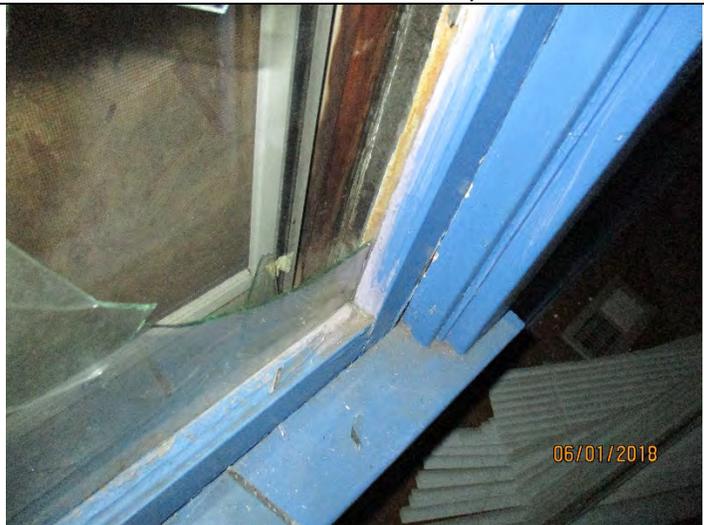
Window Glazing

Samples Represented –
4625F-EX-WG7A
4625F-EX-WG7B
4625F-EX-WG7C

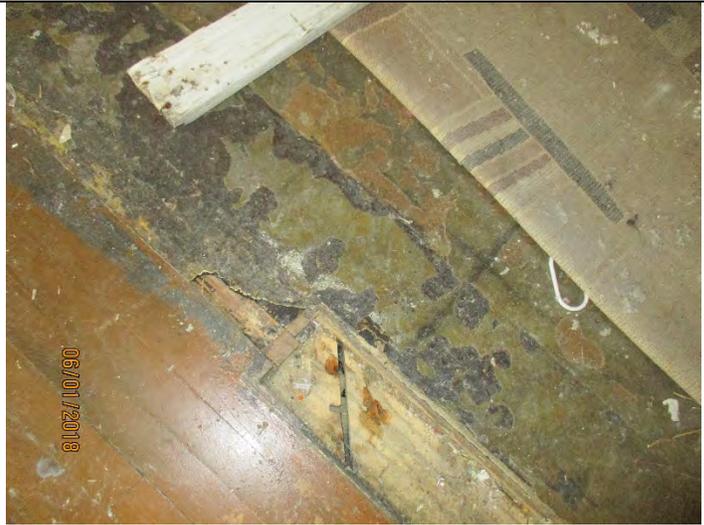
Linoleum

Samples Represented –
4625F-R1-L8A
4625F-R1-L8B
4625F-R1-L8C

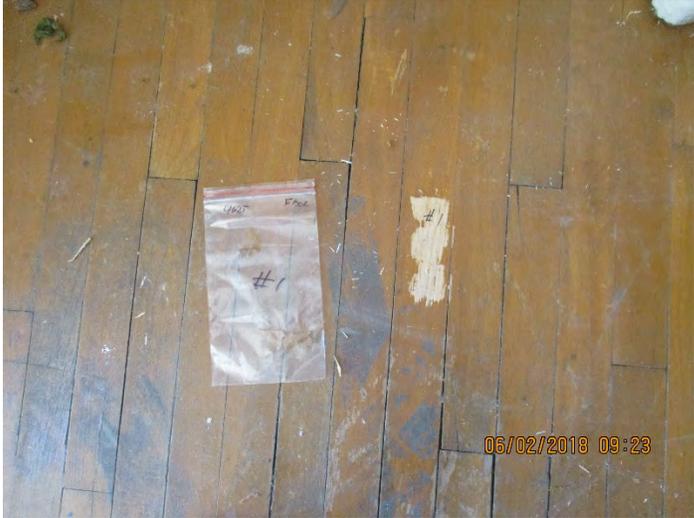
Sample Represented –
4625-L-1

Brown - LCP

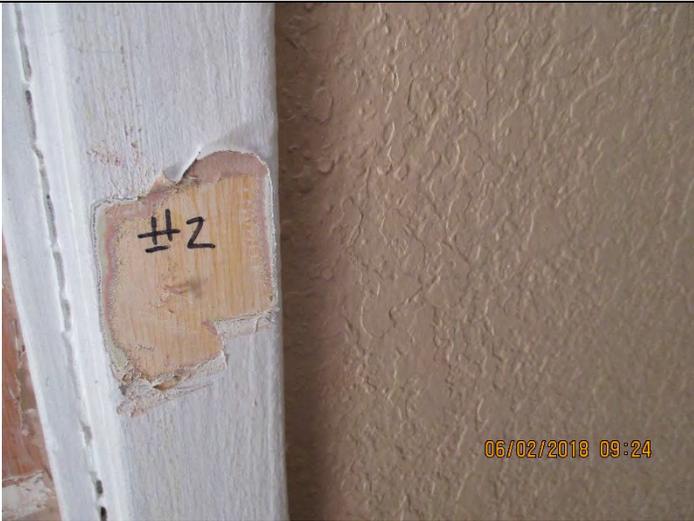
Sample Represented –
4625-L-2

White - LCP

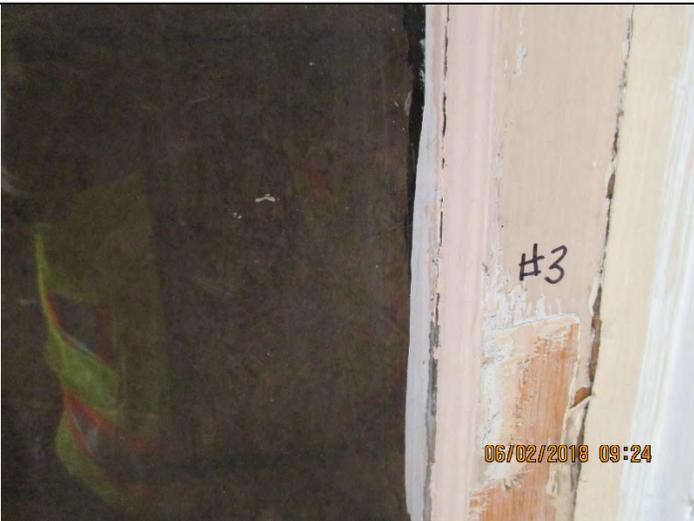
Sample Represented –
4625-L-3

Fawn - LBP

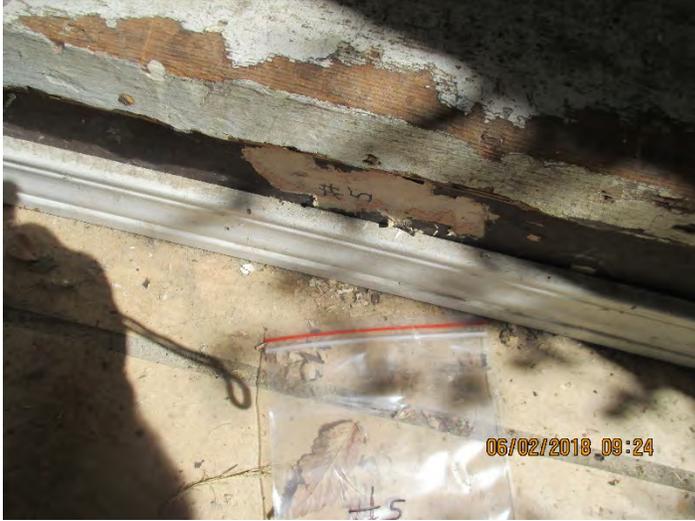
Dark Brown - LCP

Sample Represented –
4625-L-5

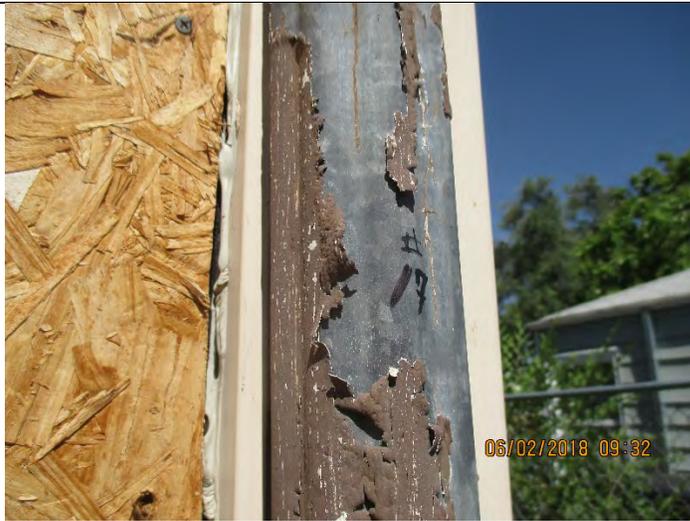
Brown - LBP

Sample Represented –
4625-L-17

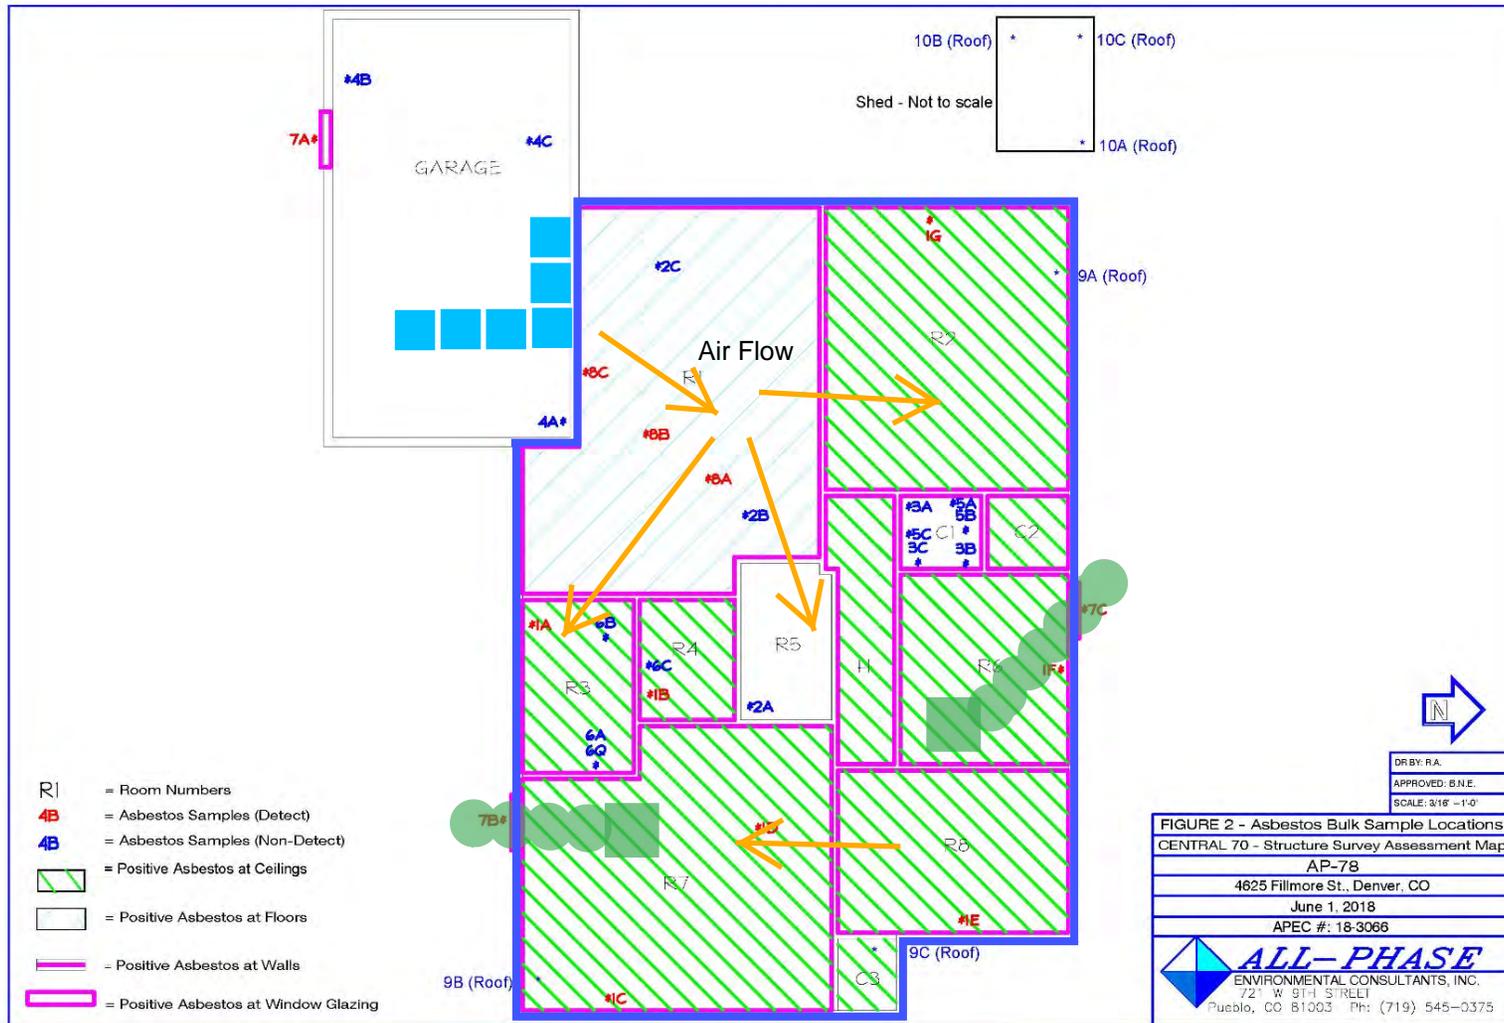
| 4625 FILLMORE STREET DENVER, CO (Not to Scale) | FEI Project #AS18207-2 | Date: 10/11/18 | Figure 1 |

ABATEMENT IN FULL CONTAINMENT
(10/23/18 - 11/6/19)

Drawing excerpted from All-Phase Inspection
